# **Safety Recall N58 / NHTSA 13V-483**

## **Reprogram Instrument Cluster & ABS**

### **Module / Alternator Ground Wire**

2014 (WK) Jeep® Grand Cherokee

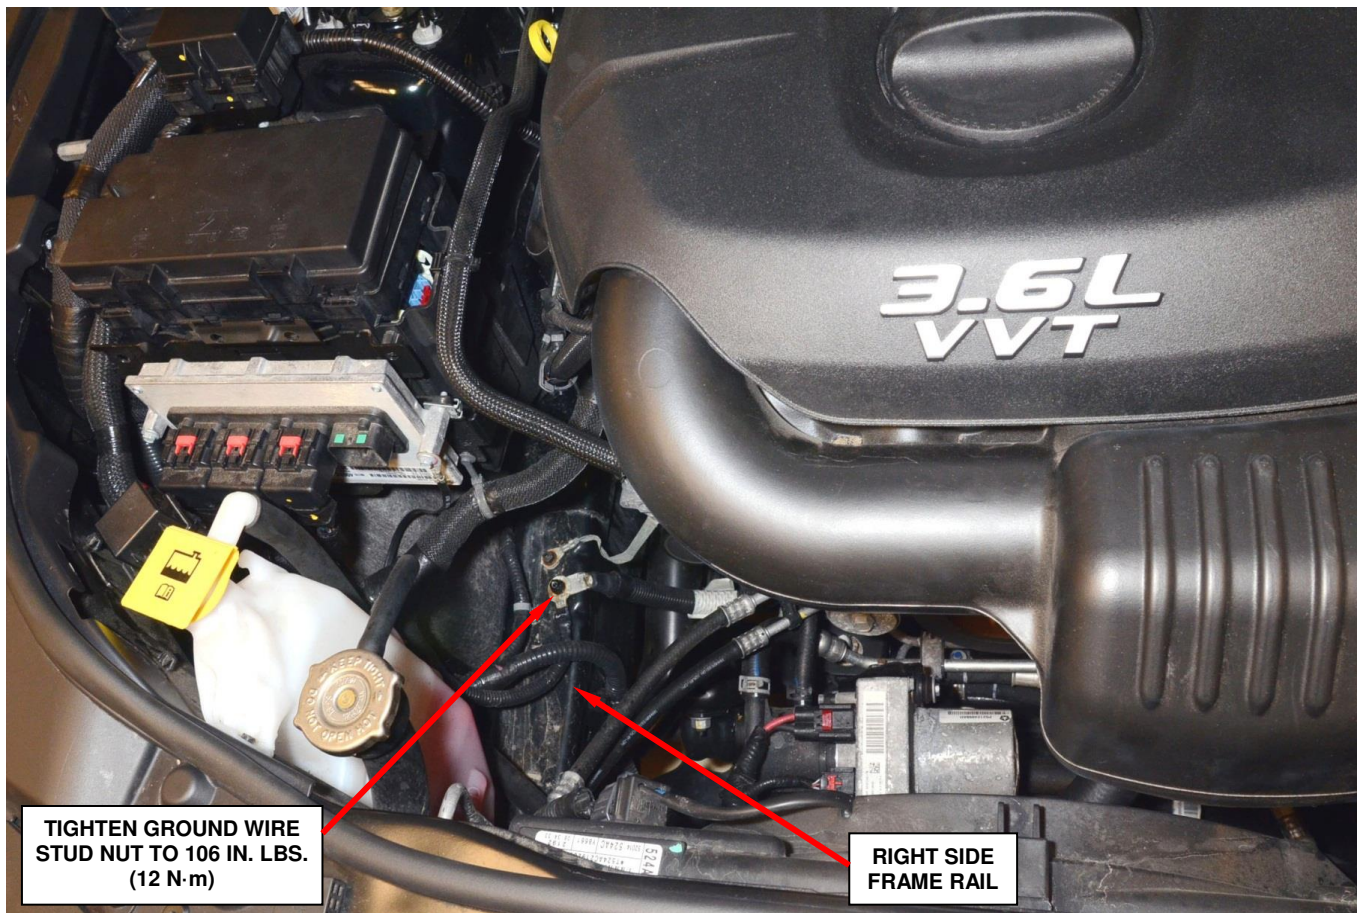
**Figure 1 – Alternator Ground Wire Location**

The instrument cluster and the ABS module must be reprogrammed. The alternator ground wire, at the right frame rail, must also be tightened.

1. Open the hood.
2. Locate the ground wire stud nut on top of the right frame rail (Figure 1).
3. Using a torque wrench and 10 mm socket, tighten the ground wire stud nut to 106 in. lbs. (12 N·m).
4. Continue with **Section B. – Reprogram Instrument Cluster & ABS Module.**
